CONTINUING ELIGIBILITY INSPECTION (CEI) REPORT
FOR FLOOD CONTROL WORKS
Honolulu Engineer District
CEPOH-EC-T

1. Project Name: Kahoma Stream FCP

2. Date of Inspection: November 3, 2005

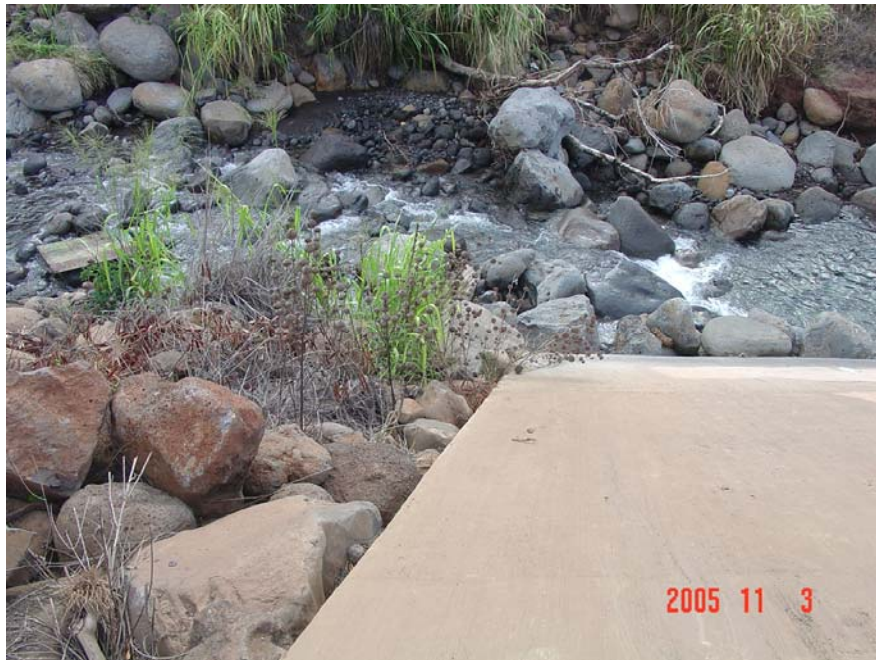
- a. Sta. 61+50, Right Bank, remove vegetation from debris basin.

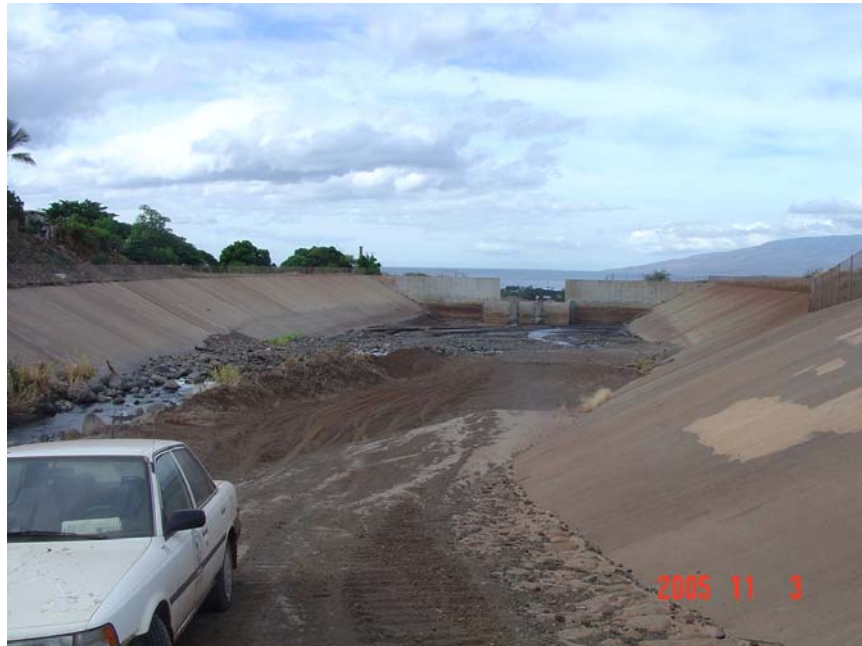
- b. Sta. 60+00, debris basin, continue to remove debris.

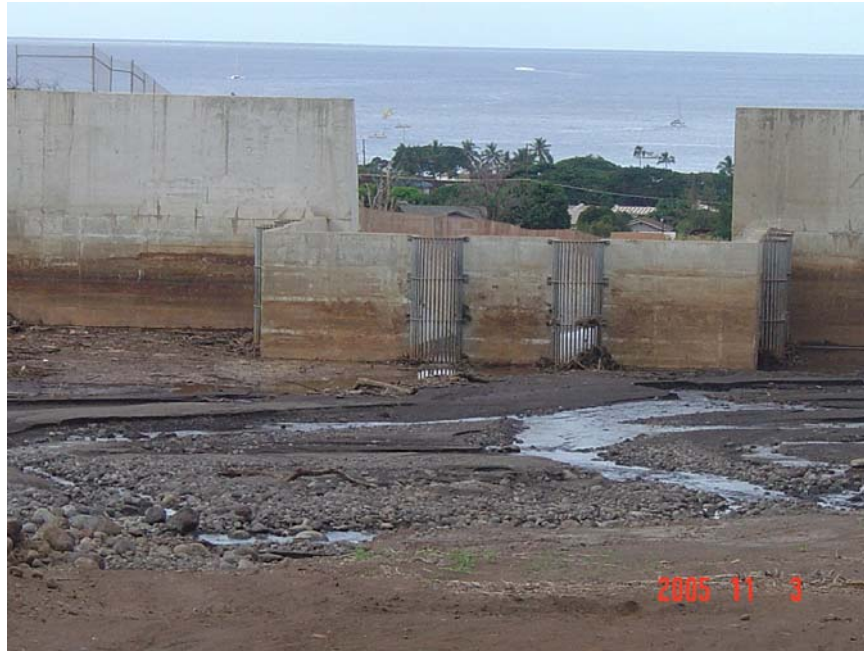
c. Sta. 59+00, debris basin, overview.

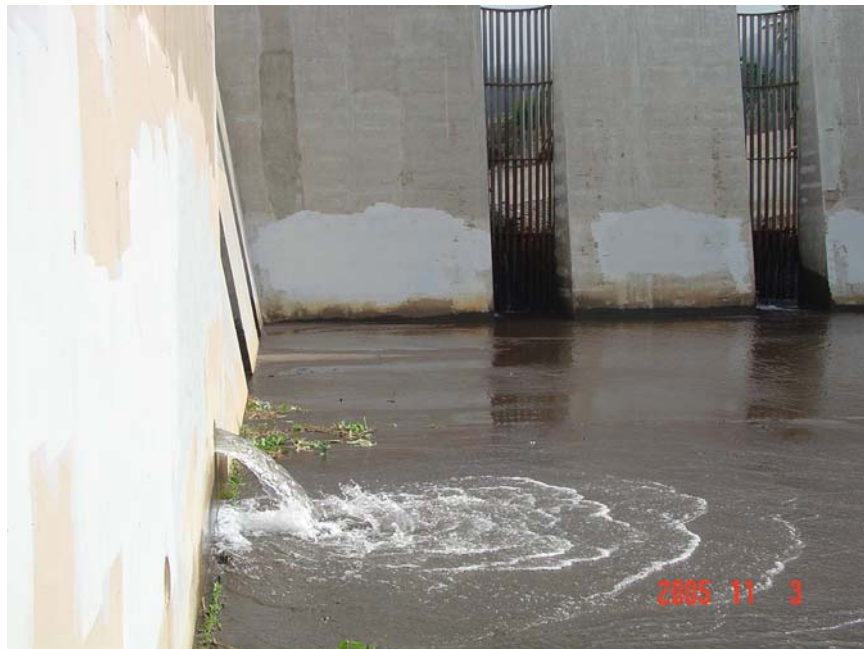
d. Sta. 55+00, debris basin, remove sediment from grating (typical).

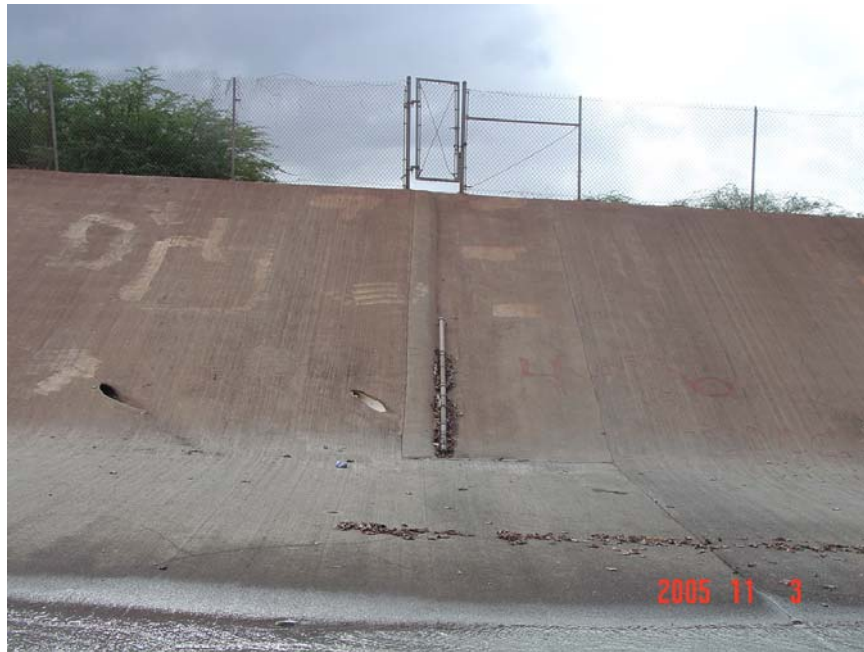
e. Sta. 50+52, Right Bank (RB), fence gate (LB) and stream gage reference point.

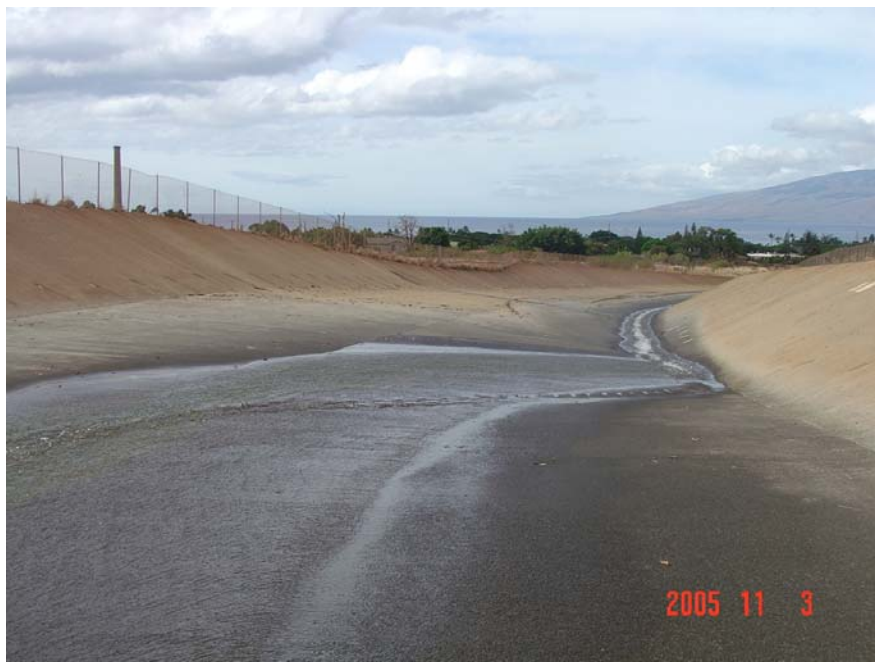
f. Sta. 49+00, Left Bank (LB), second stream gage and fence gate reference point.

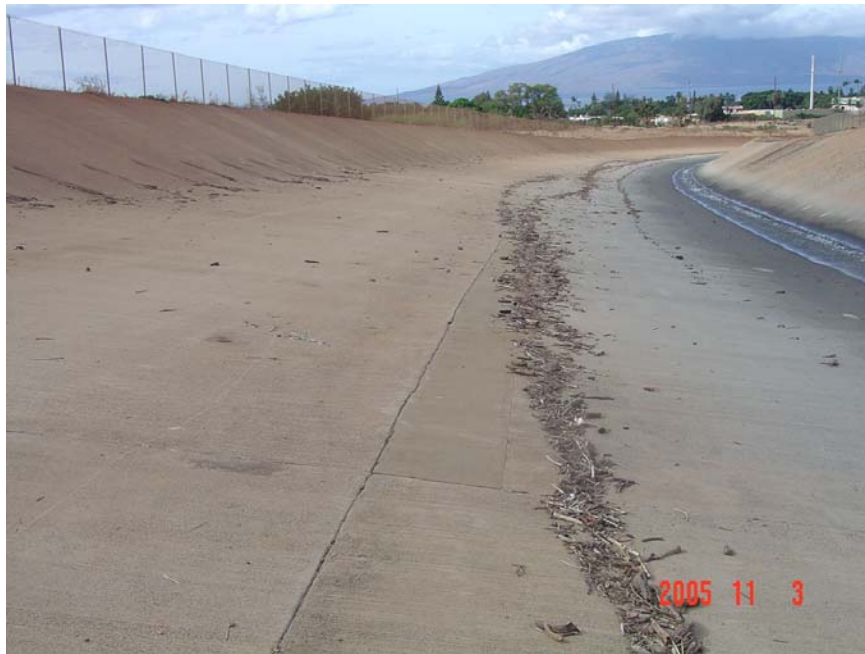
g. Sta. 45+00 to 42+49, channel, monitor hollow invert patch. Patch may have been a result of construction work to correct a late design change; moving grooved concrete swale.

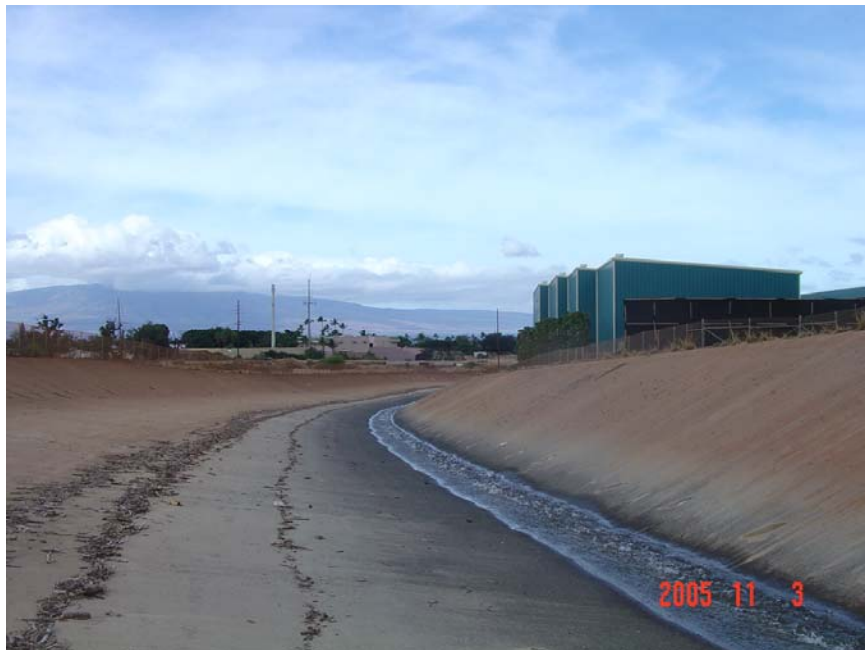
h. Sta. 39+23 to Sta. 35+93, RB. Fencing reinstalled as required.

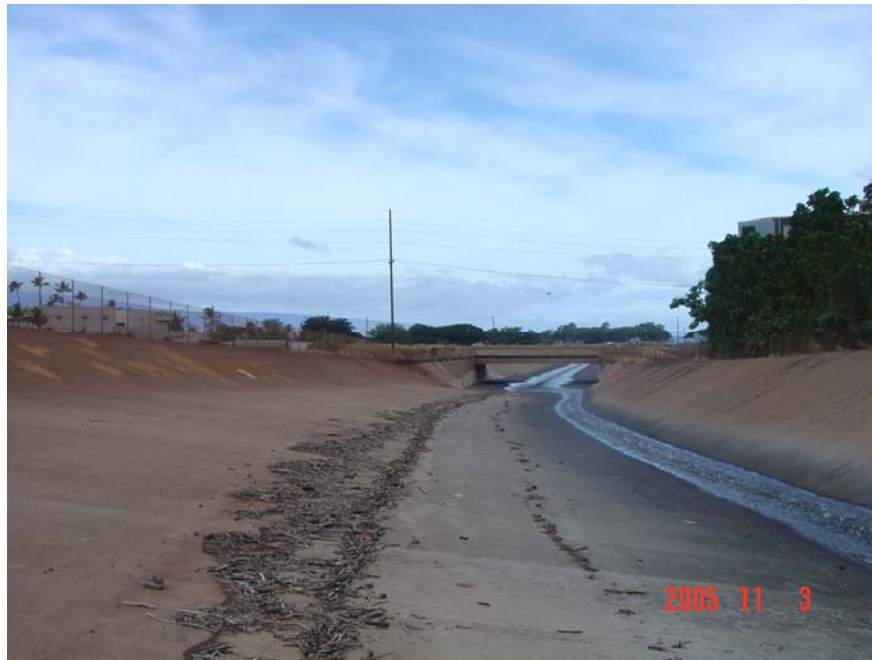
i. Sta. 27+14, Cane Haul Rd. Bridge. (reference photo)

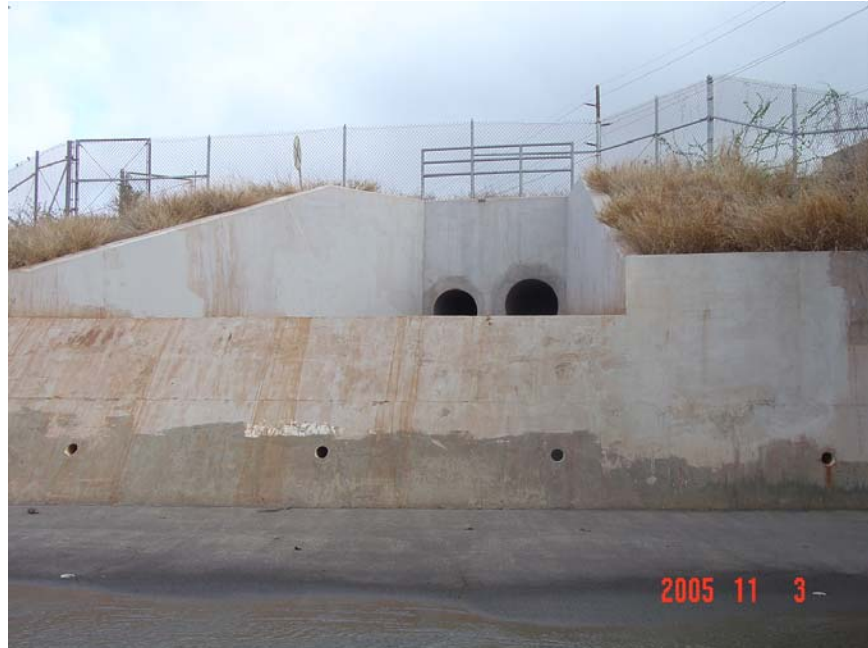
j. Sta. 26+00, RB, reference point of double drain pipes (RCP).

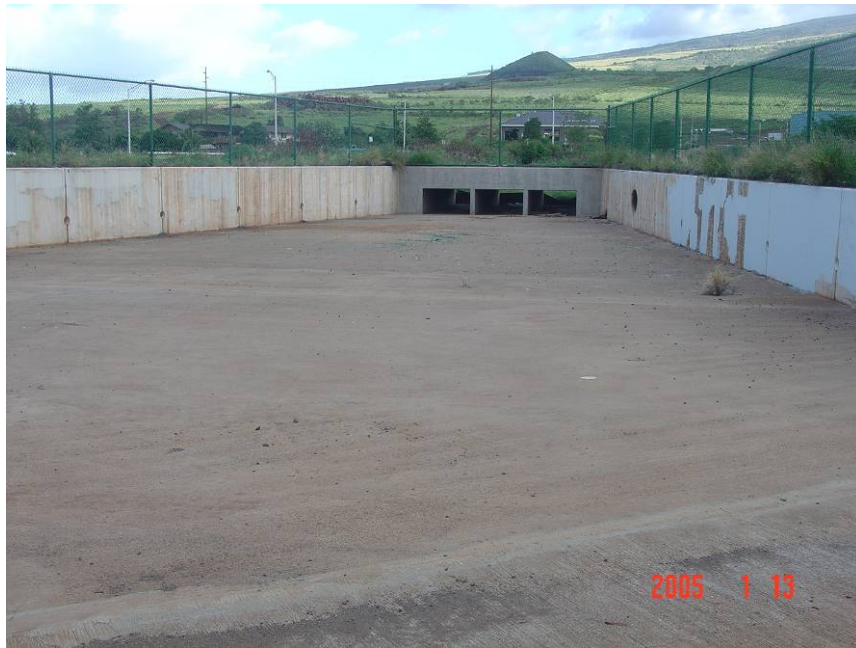
k. Sta. 21+00, RB, Triple Box Culvert, 2005 photo.

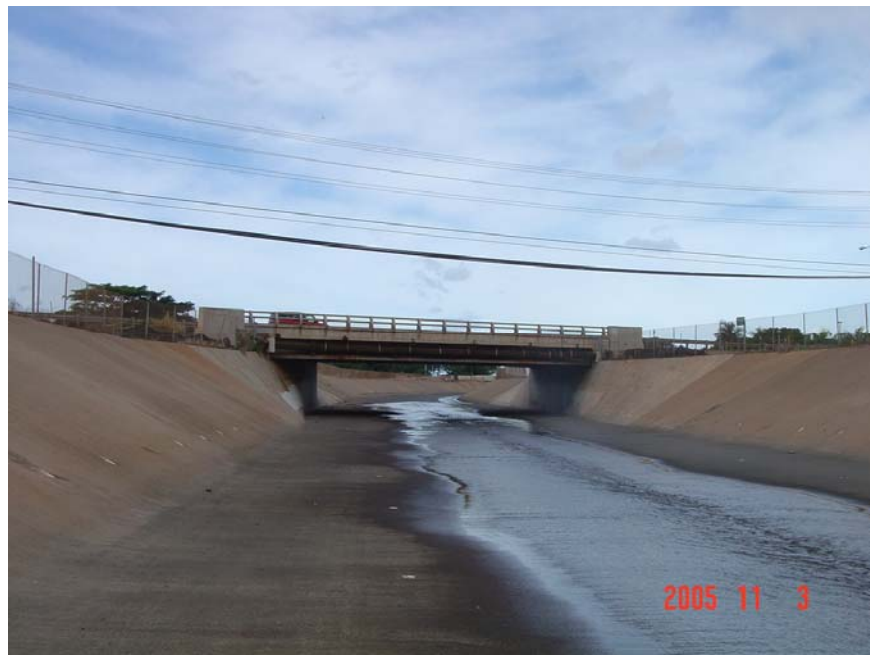
l. Sta. 17+00, RB Invert, and caulk joint.

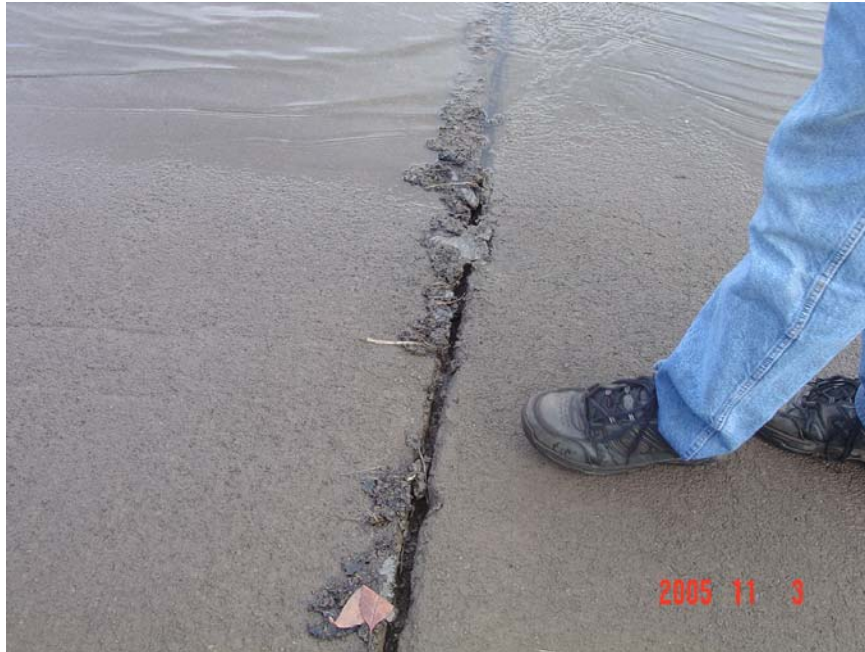
m. Sta. 6+00, RB & LB, Separation of channel invert patched, since FY04 inspection. Continue to maintain.

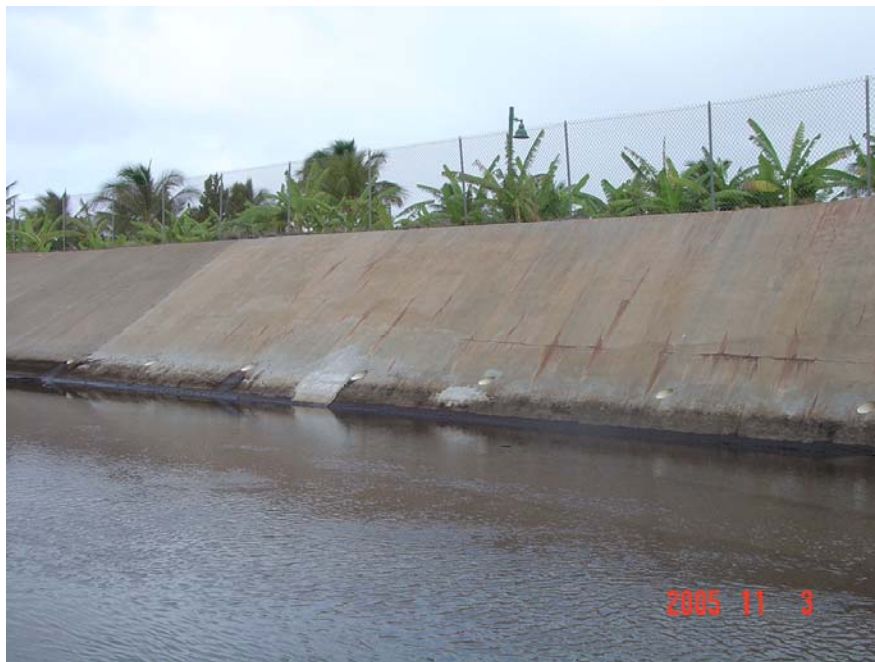
n. Sta. 5+10, Right Bank, patched spalling.

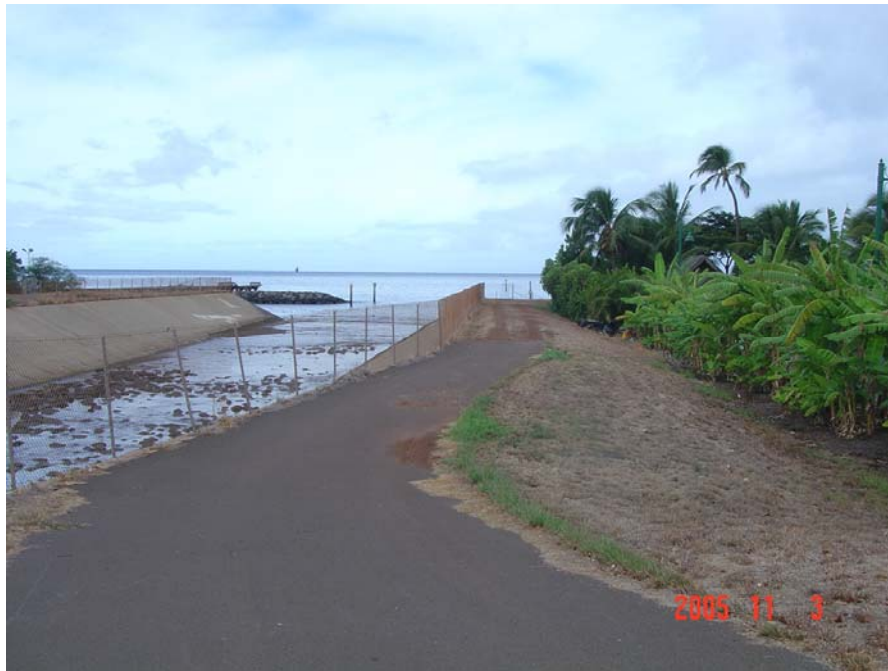
o. Approximate Sta. 3+50, RB, Vegetation on levee sideslope needs to be cut back.

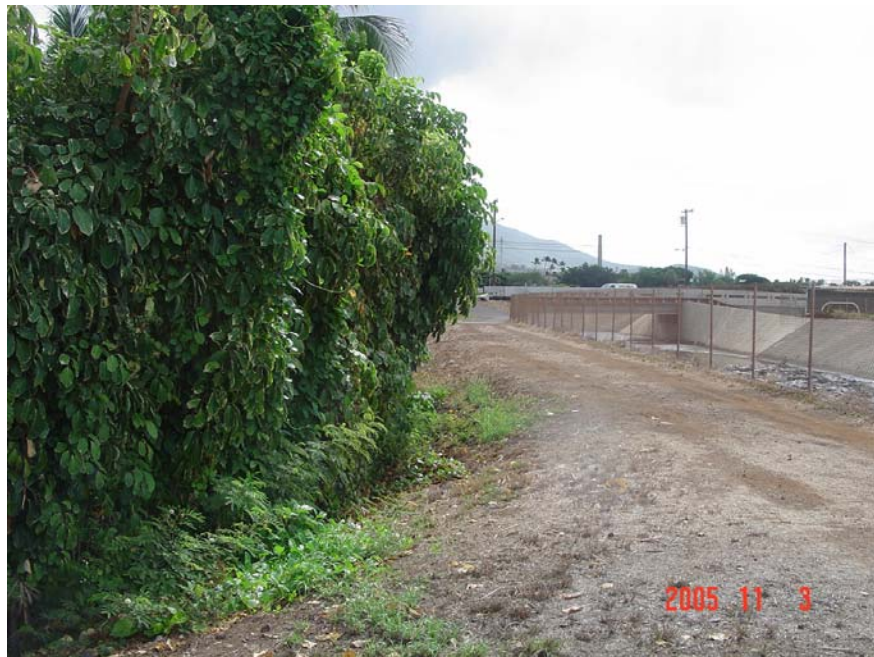
p. Approximate Sta. 1+50, RB, remove vegetation from top of bank and sideslope on townside.

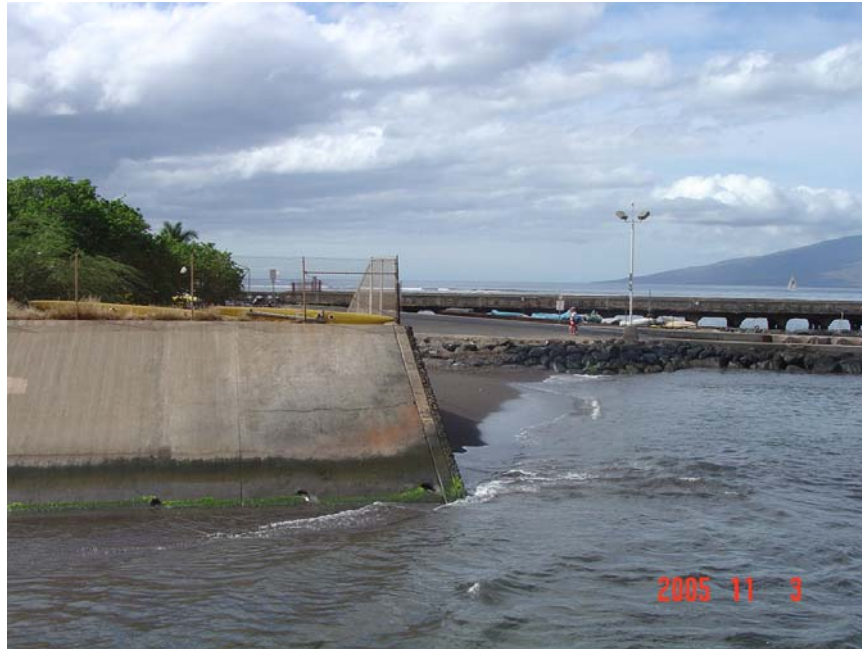
q. Sta. 0+85, LB, Beginning of concrete channel.
